# Snapshot Day

May 3<sup>rd</sup>, 2014

## Final Report

## **Executive Summary**

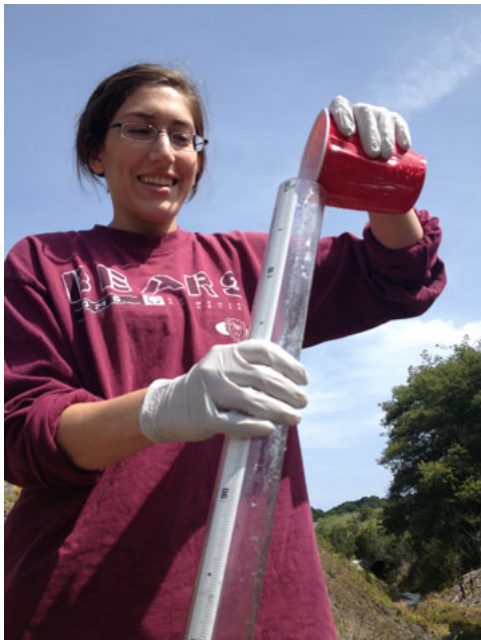
**Measuring the transparency at Tembladero Sough in Monterey County.**

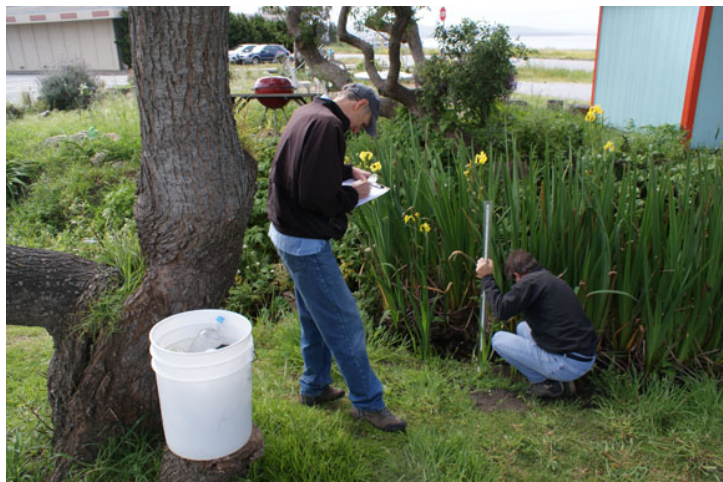
**Checking transparency at Deer Creek in San Mateo County.**

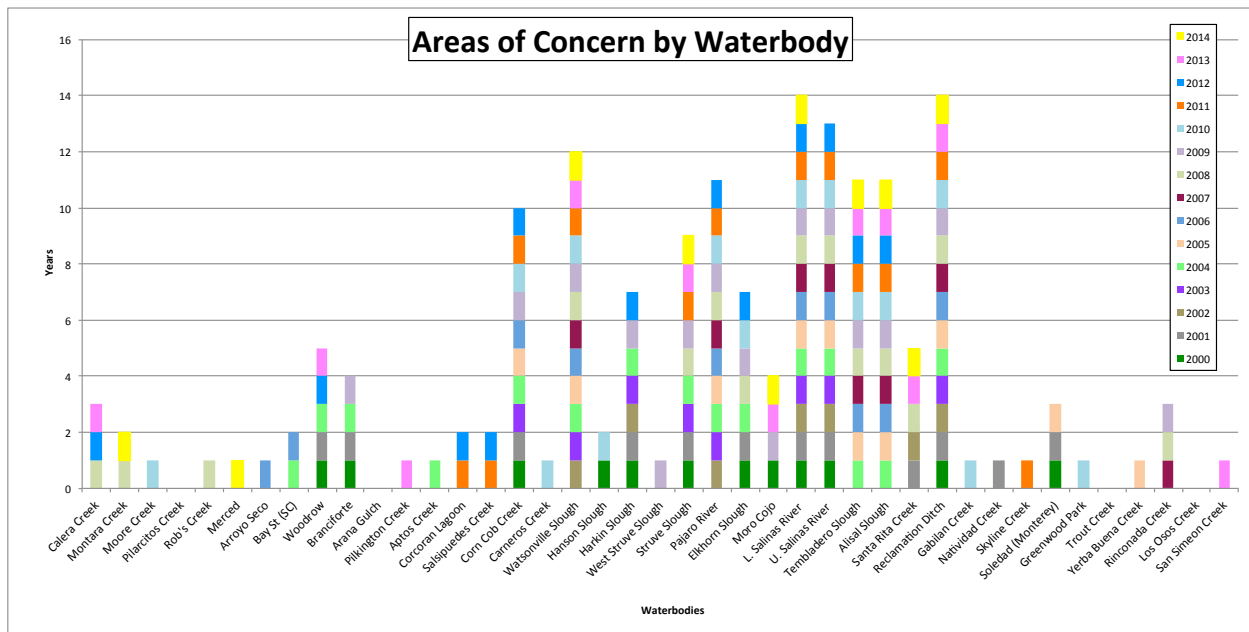
Figure 5. Areas of Concern by water body 2000-2014.

When lab and/or field results for a single site exceed three or more water quality objectives, the site is designated an Area of Concern (AoC). Over the past several years, a trend has emerged of more than one AoC per water body. For example, the Tembladero and Moro Cojo Slough have more than one site that is an AoC along the same waterway. For this reason we have chosen to display the AoC data two ways: by water body (Figure 5) and by site (Figure 6).

In 2014, fourteen sites (15%) were designated Areas of Concern on ten water bodies (Figure 5). For the most part, AoC are designated and stay on the list for many years. This year Montara Creek is on the list for the first time due to exceedances at two sites for dissolved oxygen, pH and transparency (Figure 6). The Lower Salinas River is back on the AoC list again after a one year break. The Lower Salinas River site had exceedances in dissolved oxygen, temperature and nitrate as N. All data is available in Appendix 1.
