FIGURES

Appendix A Figure 1: Plots of nitrate, orthophosphate and *E. coli* at sites that exceeded WQOs for three or more water quality parameters for at least 5 years.

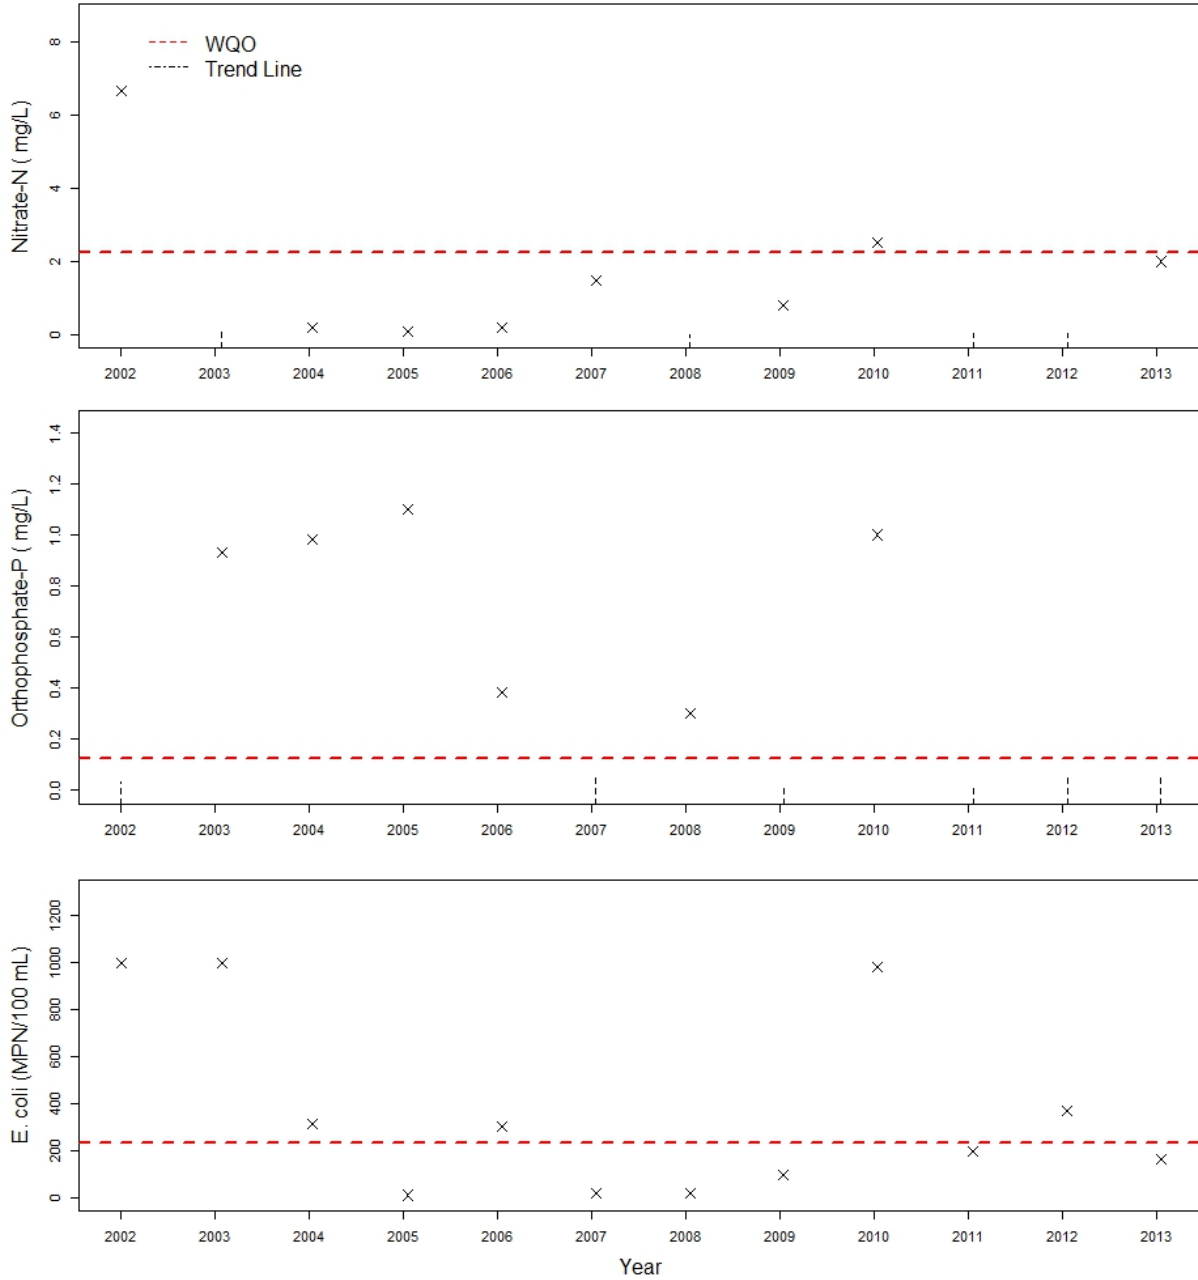
306-MOROC-32

Appendix A Figure 1 (cont'd): Plots of nitrate, orthophosphate and *E. coli* at sites that exceeded WQOs for three or more water quality parameters for at least 5 years.

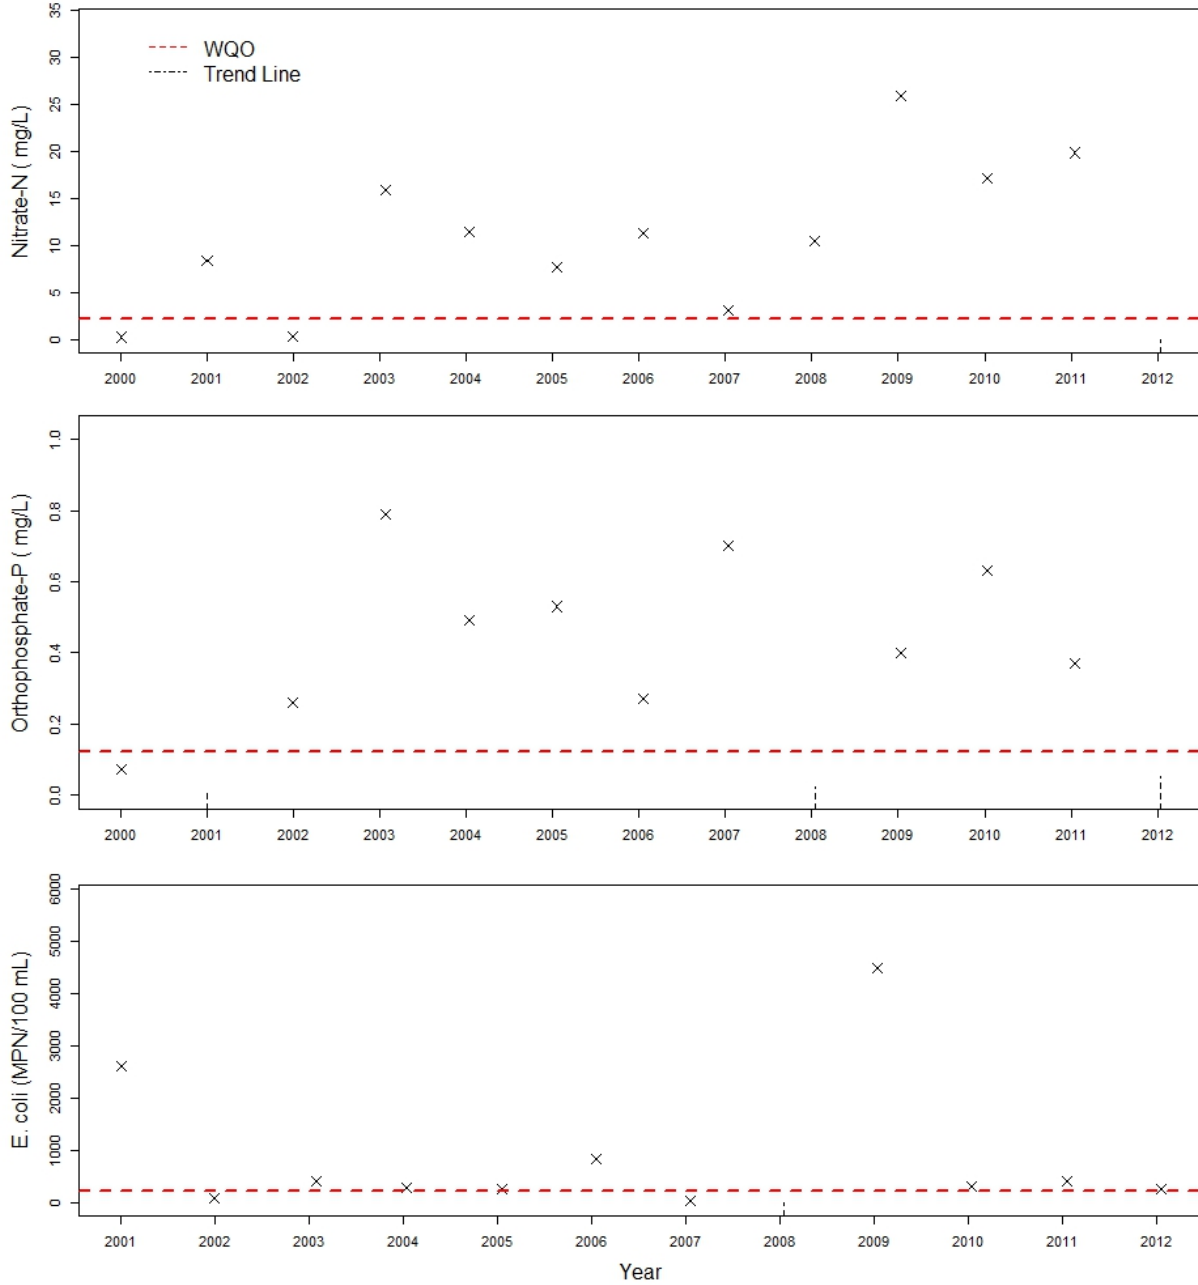
309-NATIV-31

Appendix A Figure 1 (cont'd): Plots of nitrate, orthophosphate and *E. coli* at sites that exceeded WQOs for three or more water quality parameters for at least 5 years.

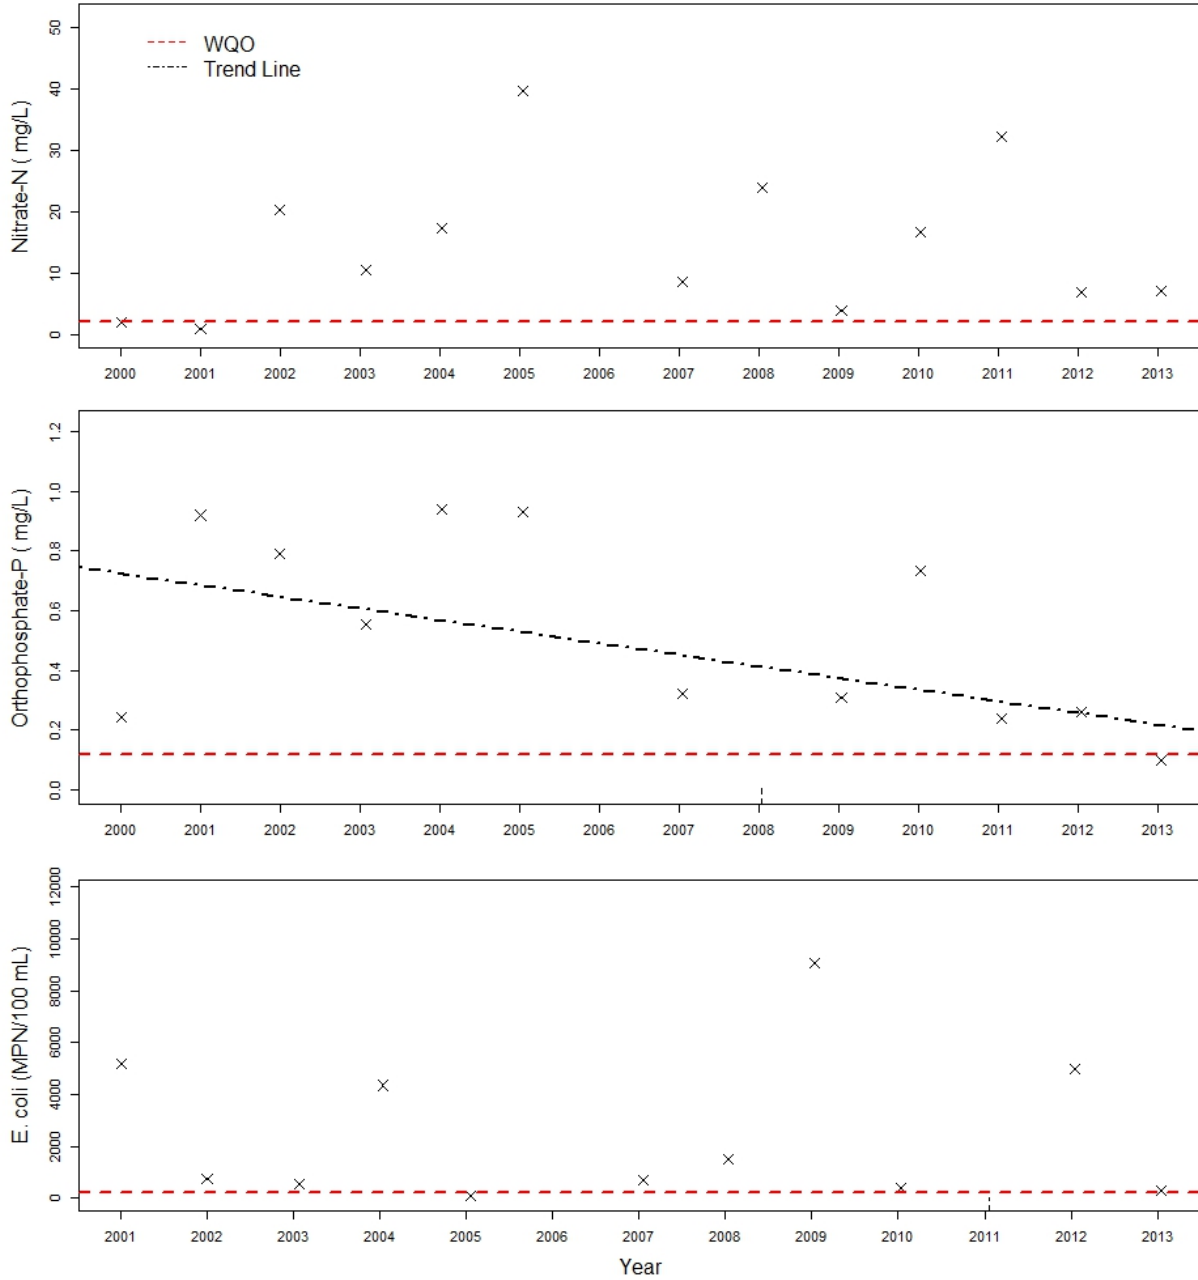
309-RECDI-31

Appendix A Figure 1 (cont'd): Plots of nitrate, orthophosphate and *E. coli* at sites that exceeded WQOs for three or more water quality parameters for at least 5 years.

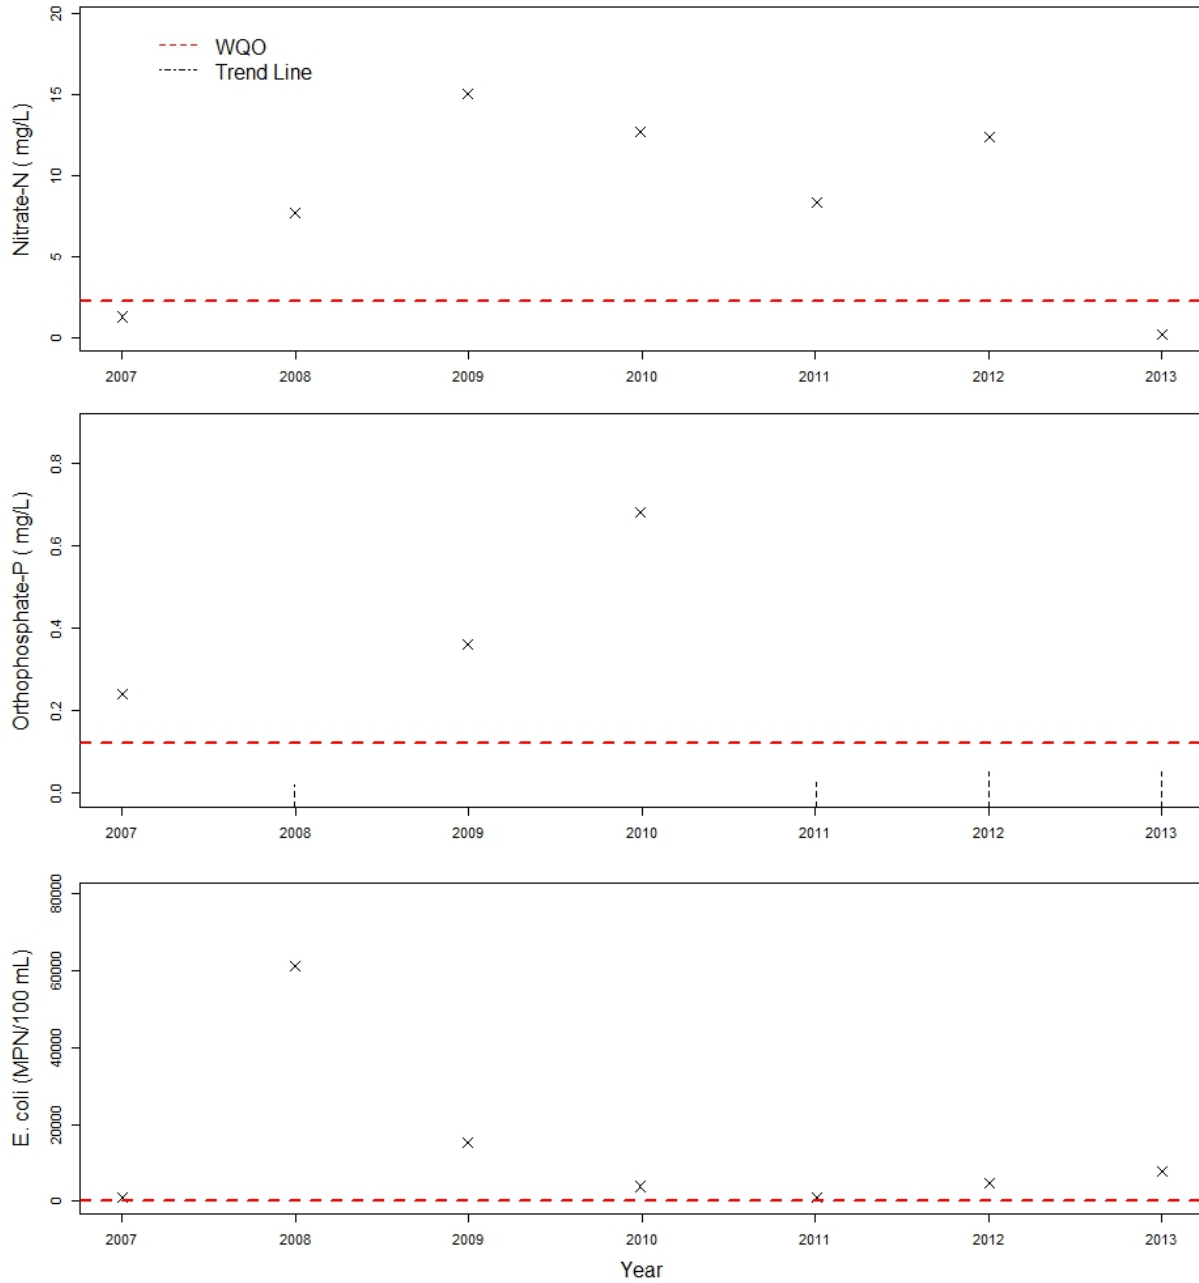
309-SRITA-32

Appendix A Figure 1 (cont'd): Plots of nitrate, orthophosphate and *E. coli* at sites that exceeded WQOs for three or more water quality parameters for at least 5 years.

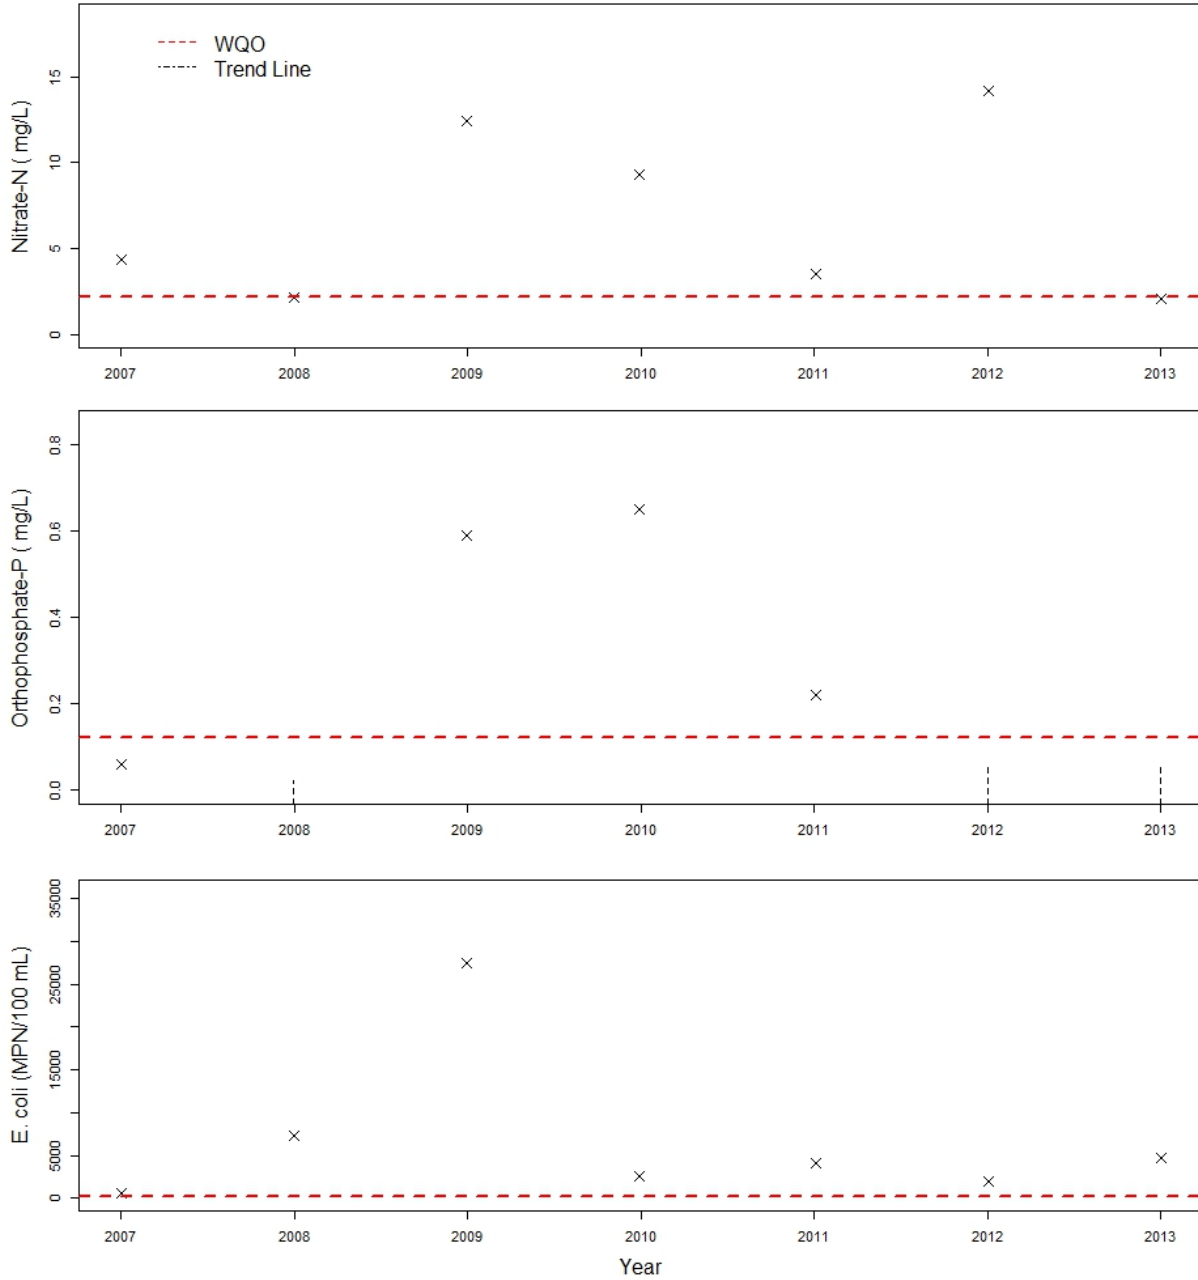
309-SRITA-34

Appendix A Figure 1 (cont'd): Plots of nitrate, orthophosphate and *E. coli* at sites that exceeded WQOs for three or more water quality parameters for at least 5 years.

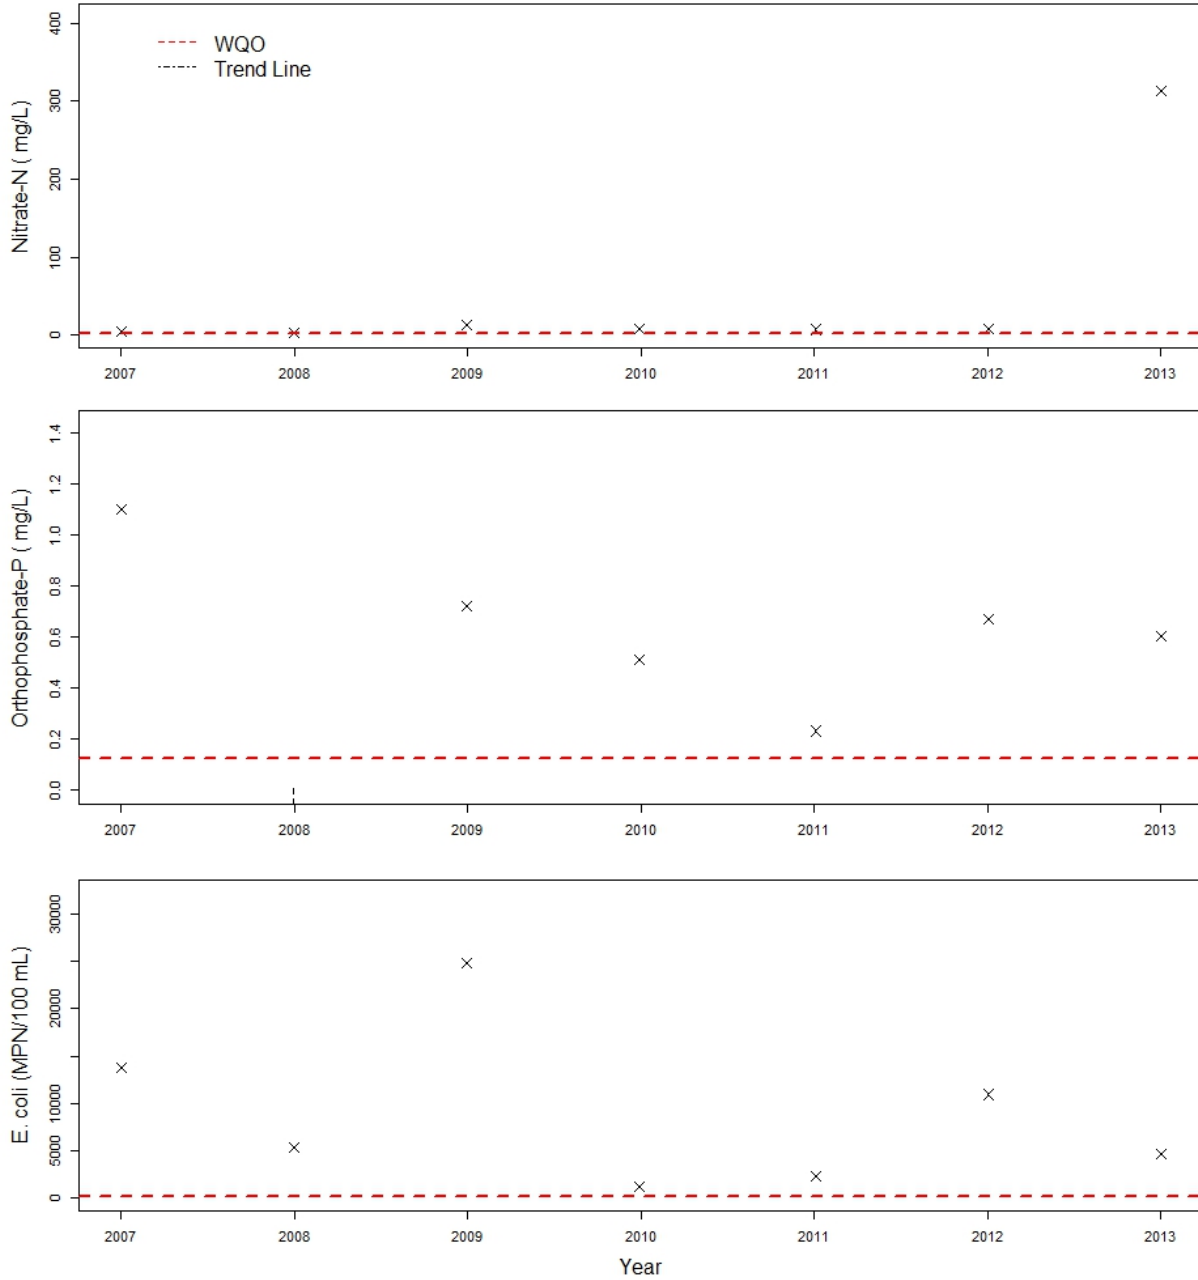
309-SRITA-35

Appendix A Figure 1 (cont'd): Plots of nitrate, orthophosphate and *E. coli* at sites that exceeded WQOs for three or more water quality parameters for at least 5 years.

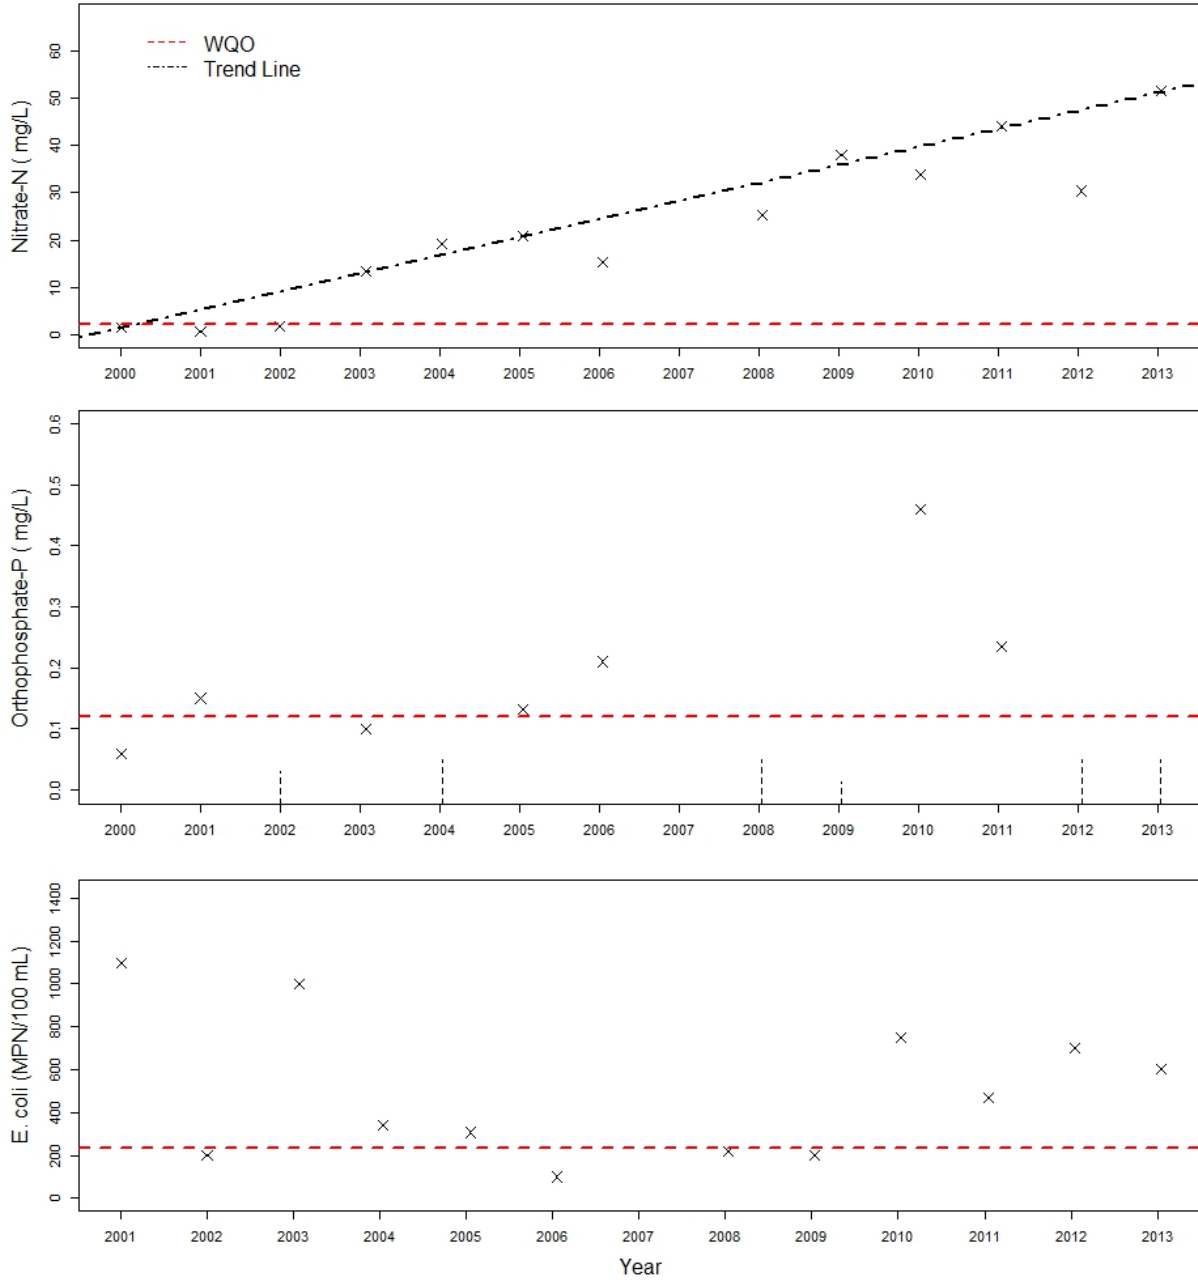
309-TEMBL-32

Appendix A Figure 1 (cont'd): Plots of nitrate, orthophosphate and *E. coli* at sites that exceeded WQOs for three or more water quality parameters for at least 5 years.

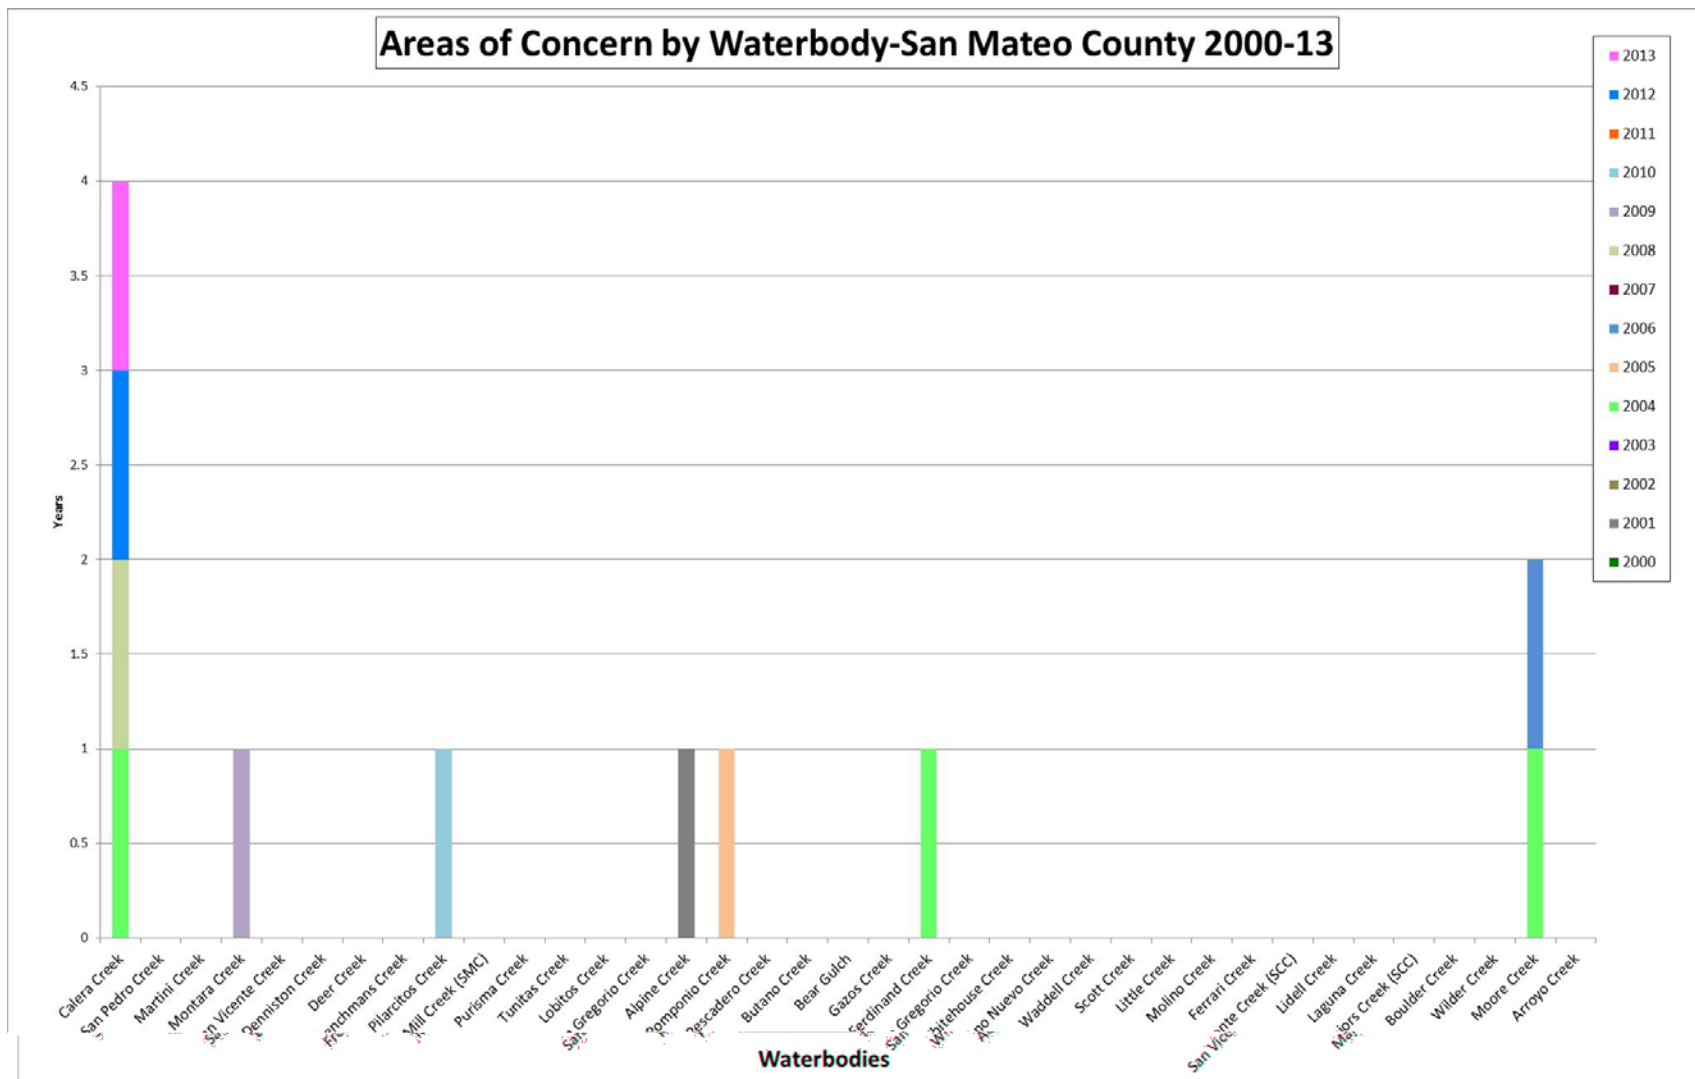
Appendix A Figure 2: Areas of Concern by waterbody for counties.

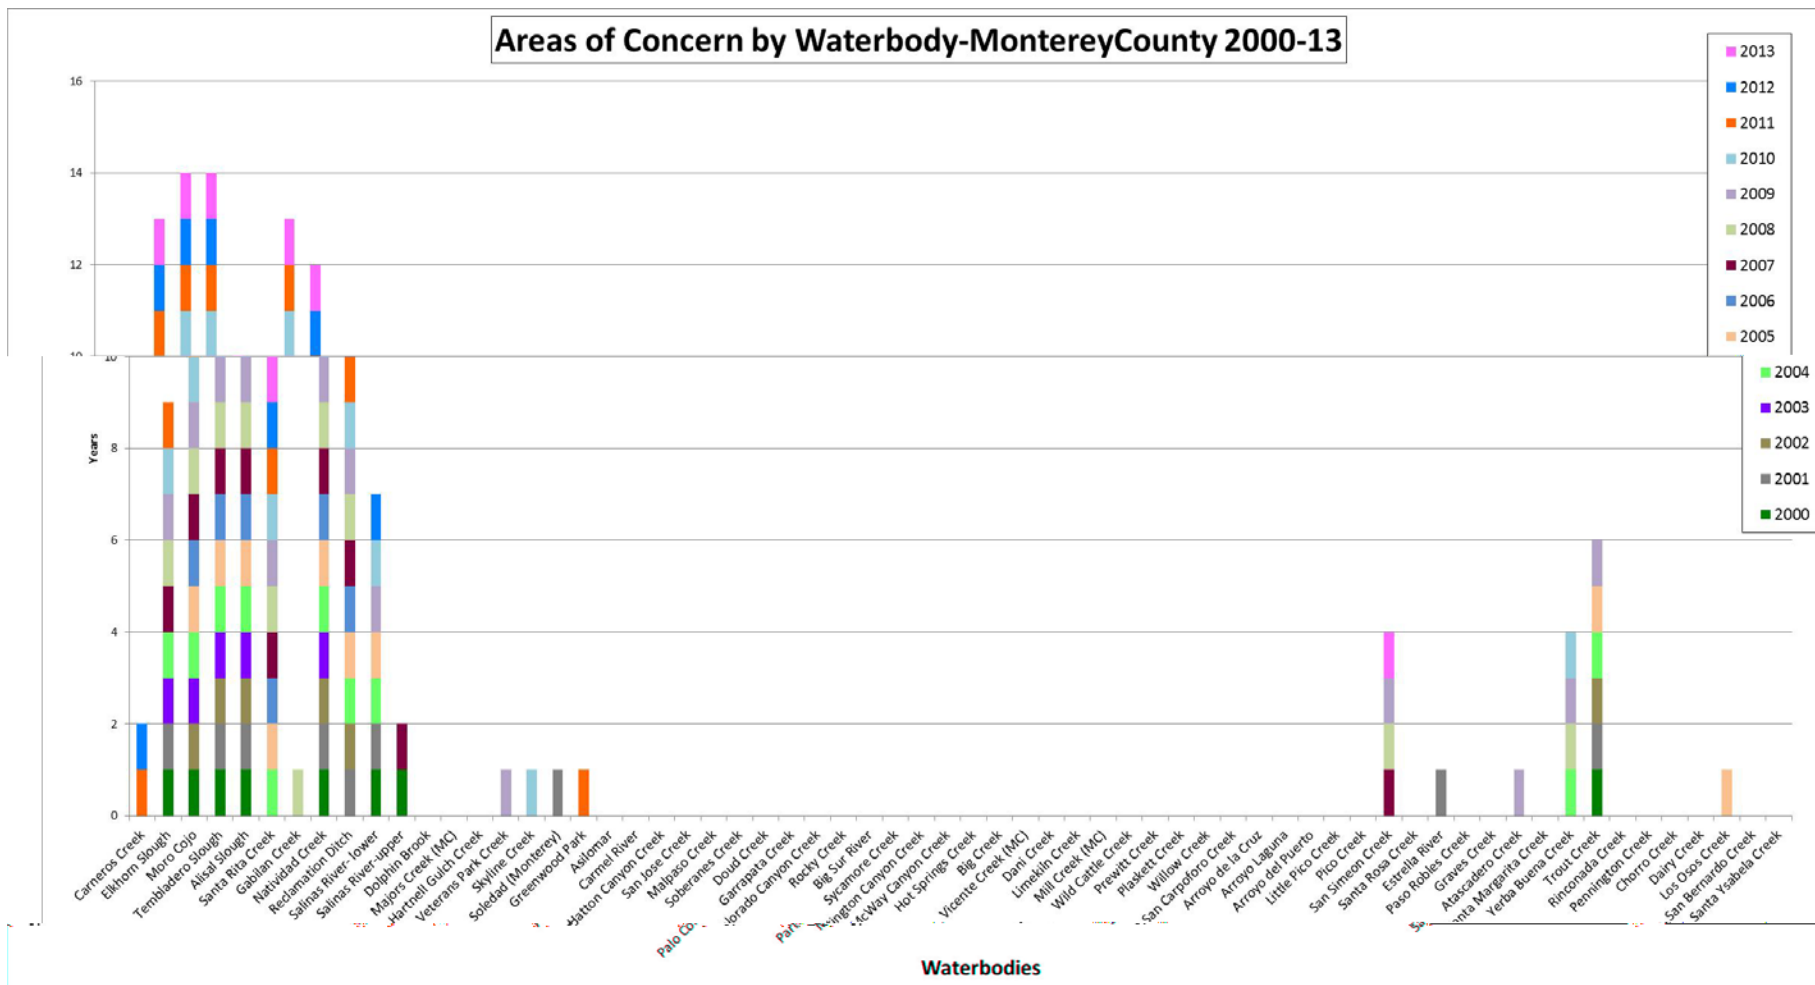
Appendix A Figure 2 (cont'd): Areas of Concern by waterbody for counties.
