A Recommendation for an  
**ENHANCED FUJITA SCALE**  
(EF-Scale)

Submitted to  
The National Weather Service  
and  
Other Interested Users

**WIND SCIENCE AND ENGINEERING CENTER**  
Texas Tech University  
Lubbock, Texas 79409-1023

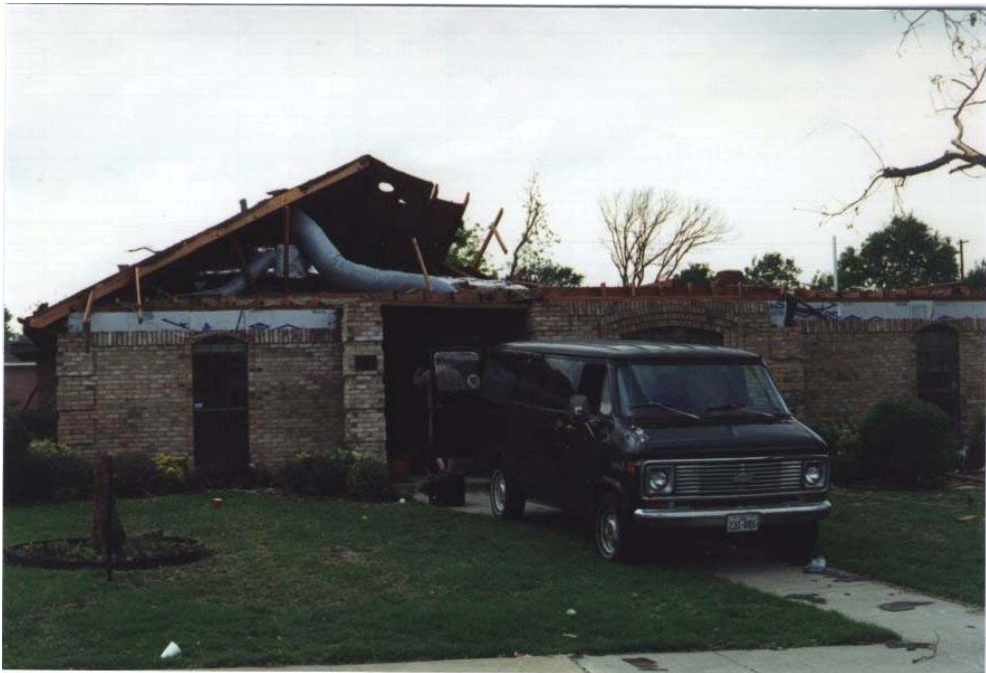
FR12: DOD 6: Large sections of roof removed; most walls remain standing

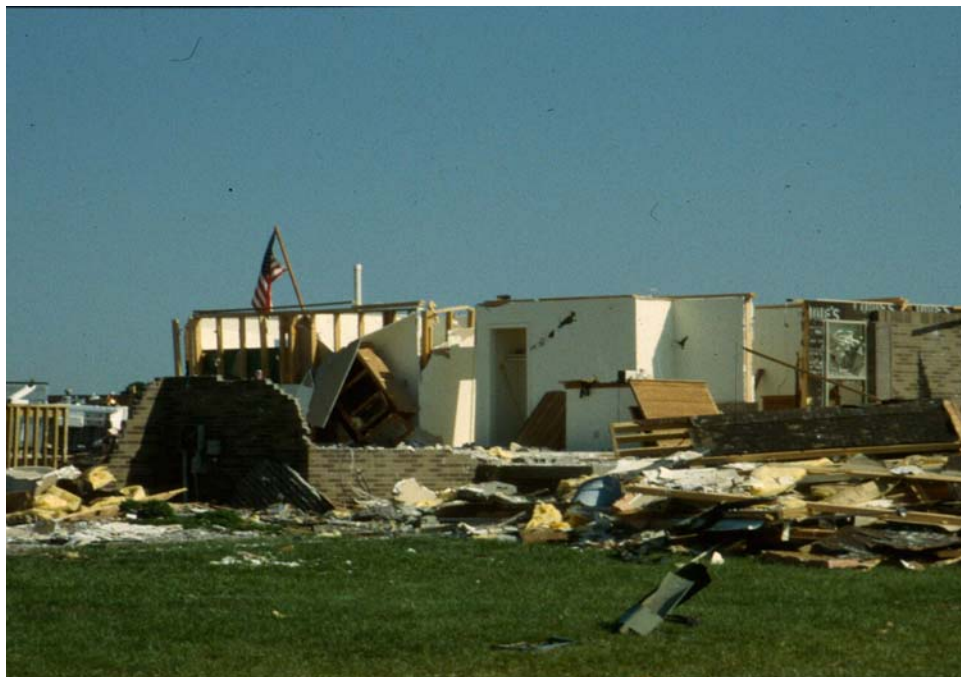
FR12: DOD 7: Top floor (First floor in this case) exterior walls collapsed

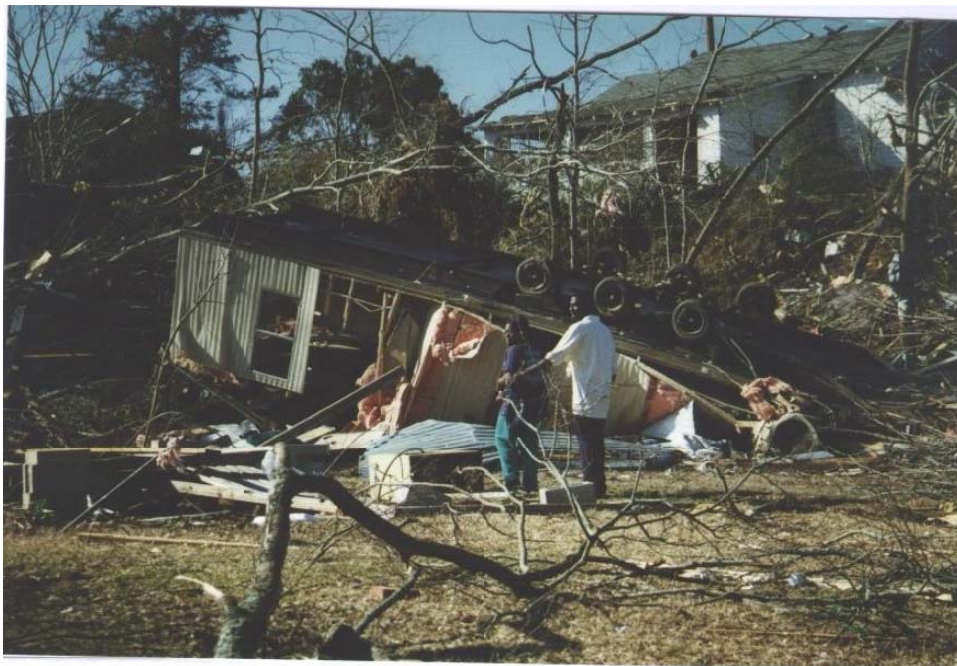
MHSW: DOD 9: Complete destruction of unit; debris blown away

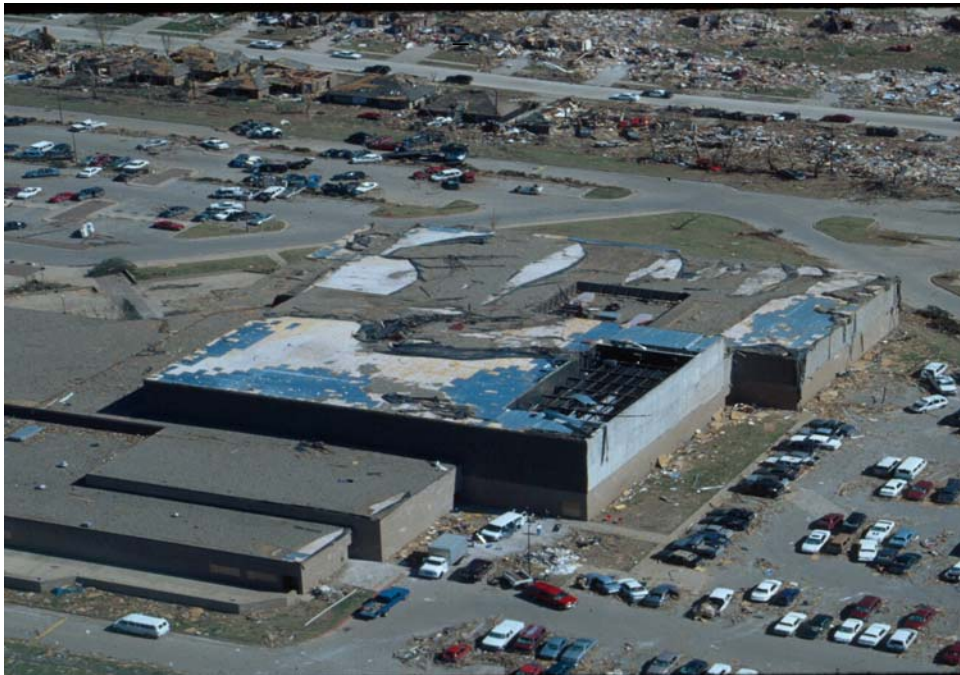
LSM: DOD 4: Uplift of some roof decking; significant loss of roofing material (>20%); loss of rooftop HVAC

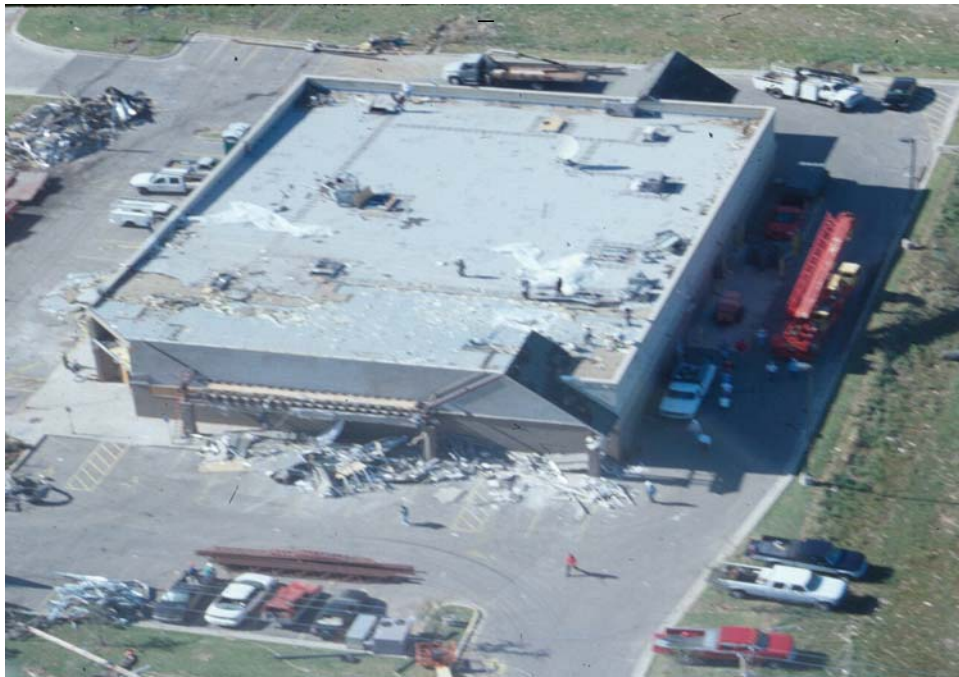
LIRB: DOD 3: Significant loss of roofing material; loss of rooftop HVAC

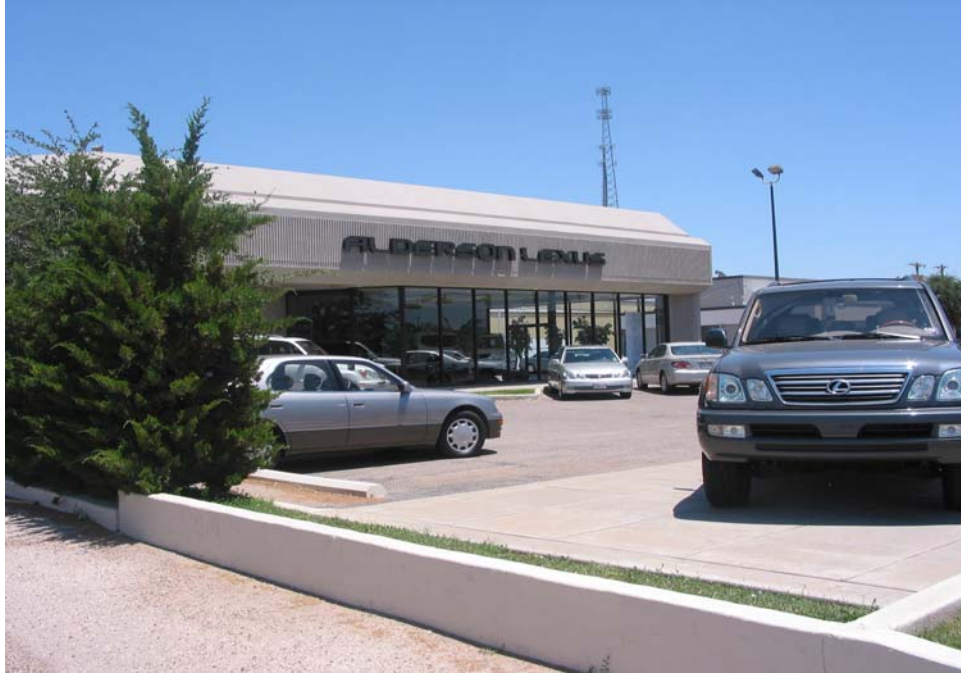
ASR: Single story with flat roof; BUR or single-ply membrane;  
metal or plywood roof deck; stud walls with EIFS,  
stucco or tilt-up panels

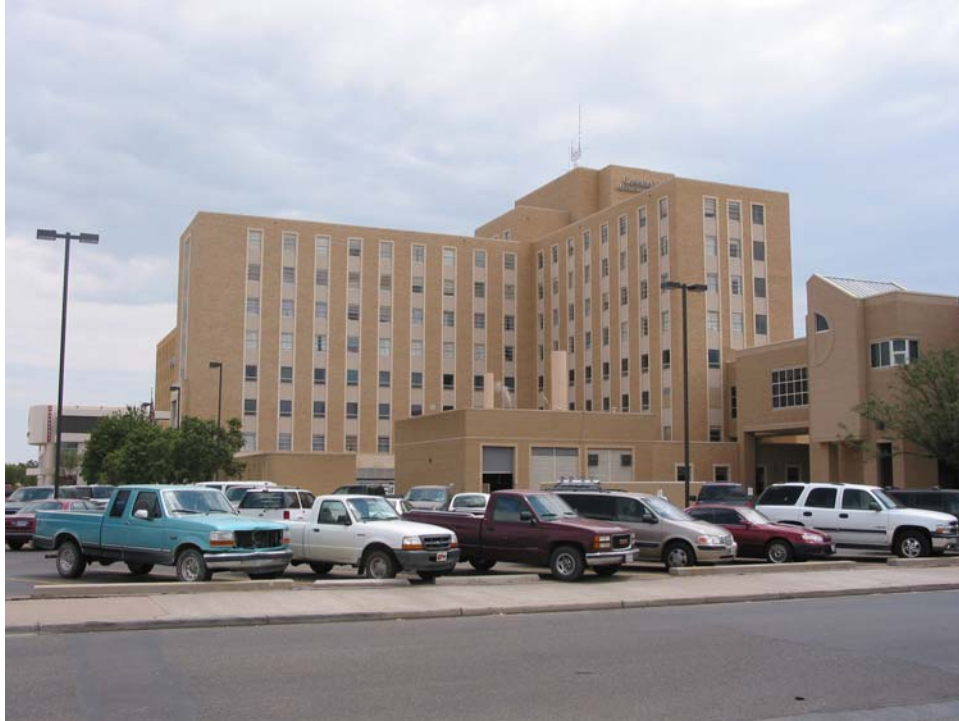
IB: Height from 1 to 10 stories; single-ply membrane, polyurethane foam, or metal roof systems; masonry, cut-stone or pre-cast wall panels; balconies, porches, or porticos; heavy façade; relatively small windows

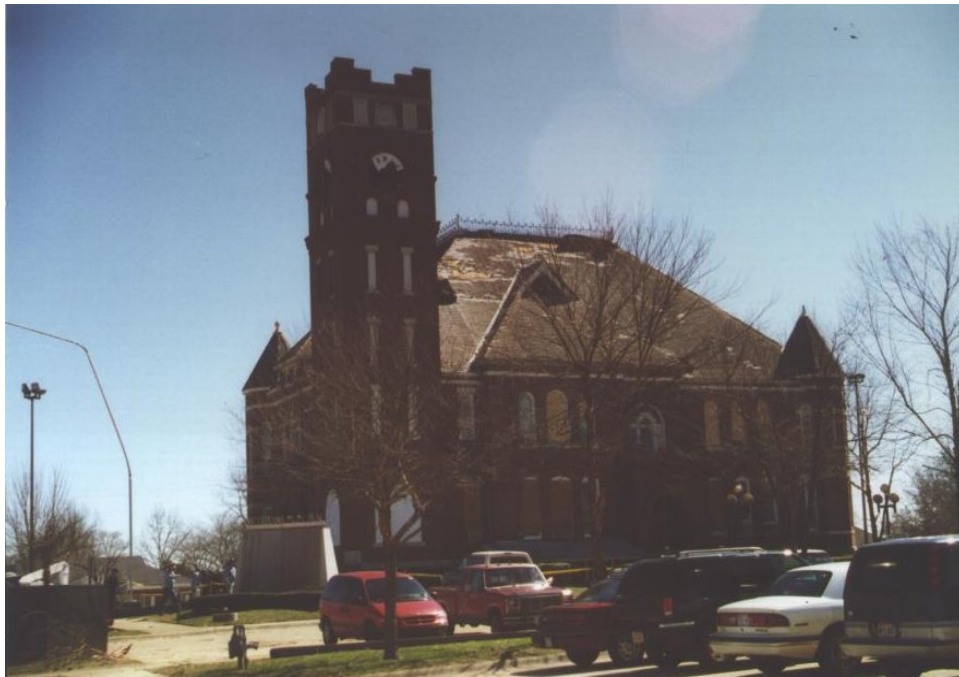
IB: DOD 6: Uplift of light-weight roof deck and insulation; significant loss of roofing material (>20%)

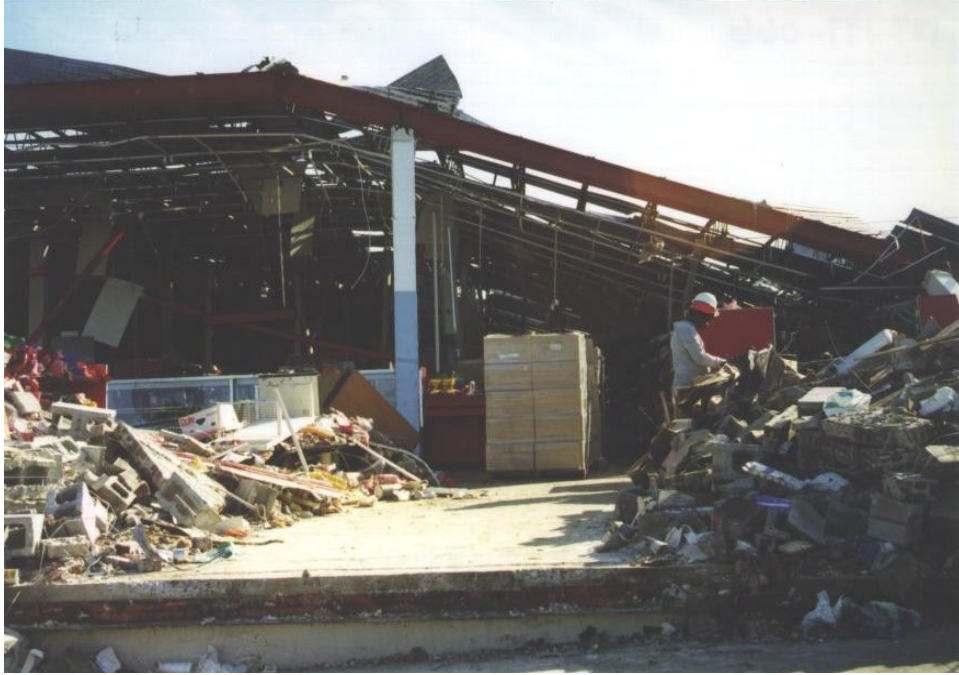
WHB: DOD 7: Total destruction of a large section of building

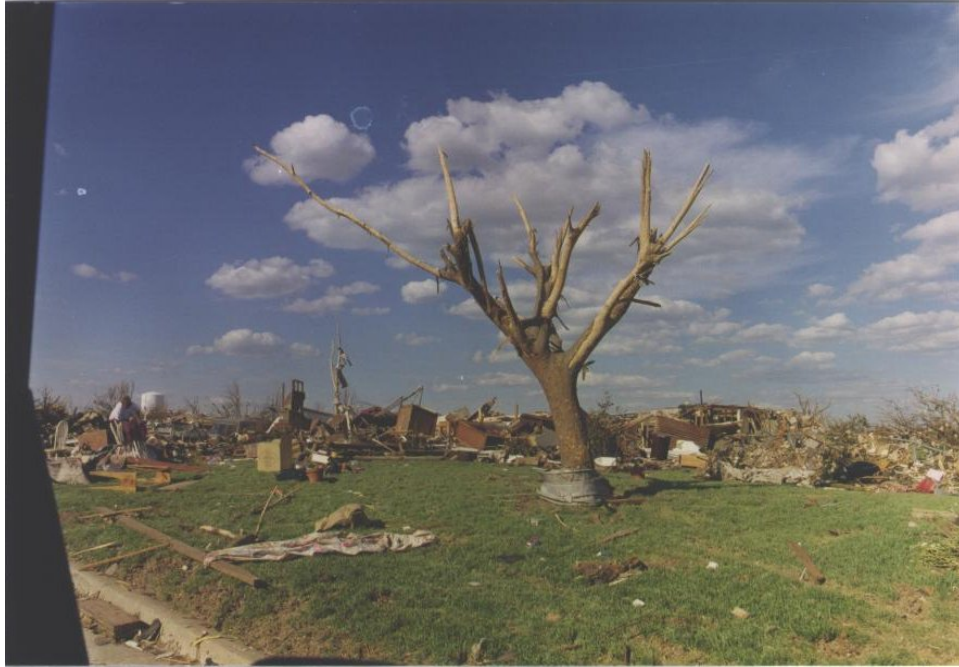
TH: DOD 5: Tree debarked with only stubs of largest branches remaining
