**Cost and Constructability of Permafrost Test Sections Along the
Alaska Highway, Yukon**

Donna Reimchen, Government of Yukon
Guy Doré, Université Laval
Daniel Fortier, University of Montreal
Bill Stanley, Government of Yukon
Robin Walsh, Government of Yukon

2009 Annual Conference
Transportation Association of Canada
Vancouver, British Columbia

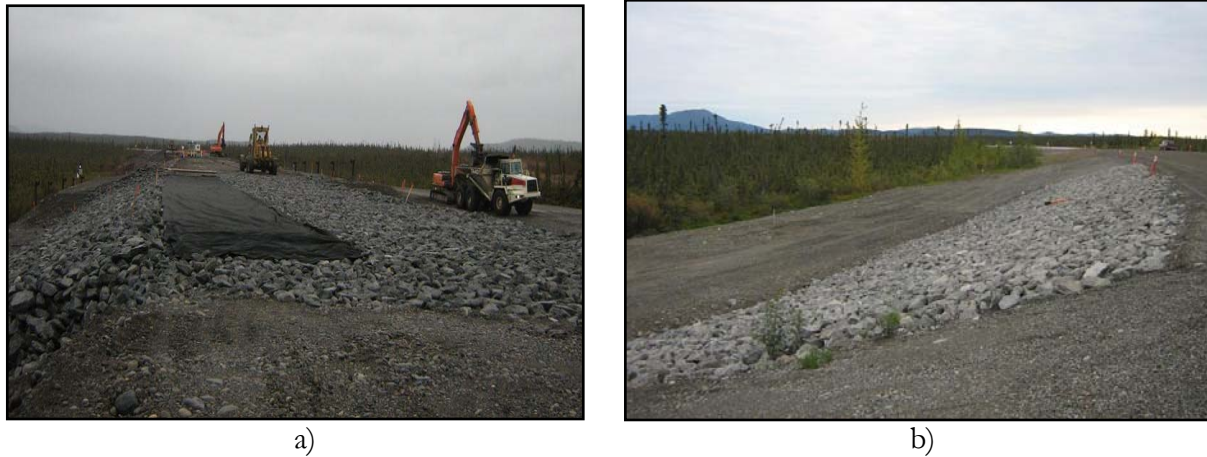
Each ACE area was excavated to within 70 cm of the ground water level. As soon as possible after the excavations were complete, they were backfilled with ACE rock. Due to the long haul involved in moving the rock to the construction site and the need to effectively use the equipment on site, some of the excavations were brought to 1 m above grade and left that way for several days, until enough rock was on site to begin a substantial portion of the backfill. In Figure 5, the full ACE embankment and uncovered ACE slopes sections have the entire rock fill in place.

Figure 5: a) Full ACE embankment built; placing geotextile prior to base course. b) Finished uncovered ACE slopes section.

The full ACE section was backfilled with ACE rock as material was available. The side slope sections were given priority over the full section. As a result, the full section was left open for a significant amount of time, particularly the east side of the road, as backfilling began on the west side and proceeded towards the east side. As the site is monitored over the next several years, it will be observed whether there is a difference in road surface integrity between the two sides.
