Monterey Bay Sanctuary Citizen Watershed Monitoring Network
299 Foam Street Monterey, CA 93940 Bus. (831) 883-9303 Fax (831) 883-4748

First Flush Report

October 30, 2001

**In the Cities of
Monterey, Pacific Grove and Santa Cruz, CA**

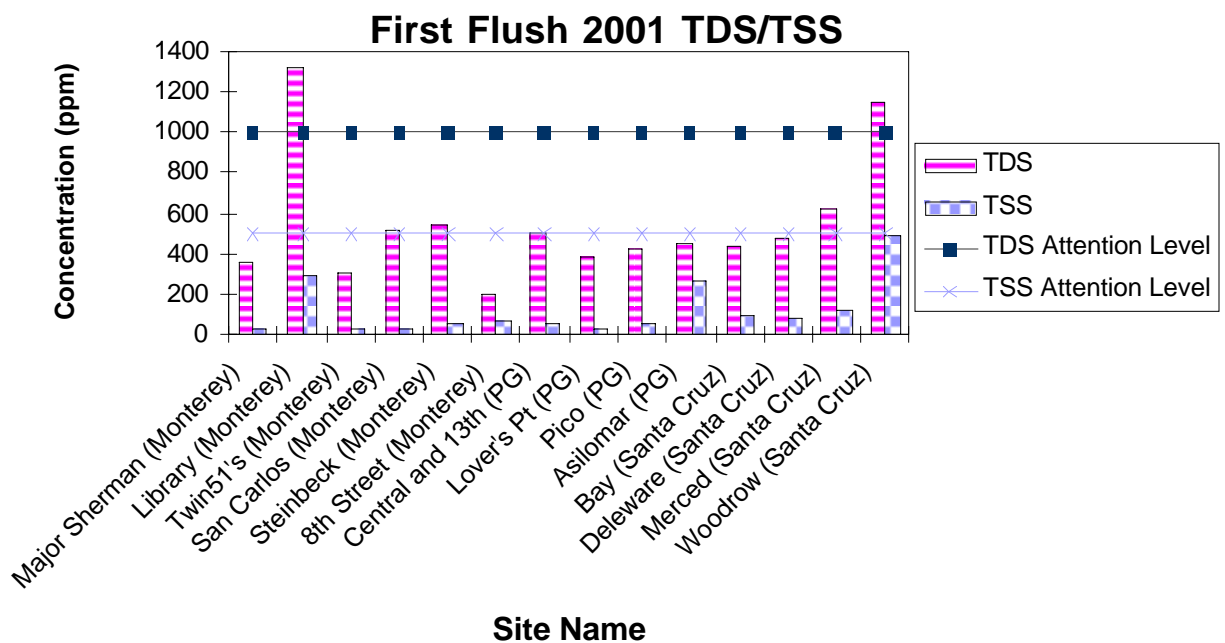
TDS and TSS both were in very low concentration at most of the sites. The CCAMP Action Levels are 1000 ppm for TDS and 500 ppm for TSS. In 2000, no stations exceeded these levels. This year, Library and Woodrow exceeded the TDS action level. The first sample taken in the time series for Woodrow was the highest for TDS at 1148 ppm and the last sample taken was the highest for TSS at 487 ppm. (See Figure 2).

Figure 2. Total dissolved solids and total suspended solids in concentrations (ppm) by site. The sites are listed by city traveling from east to west. The values for time series locations reflect the maximum result.

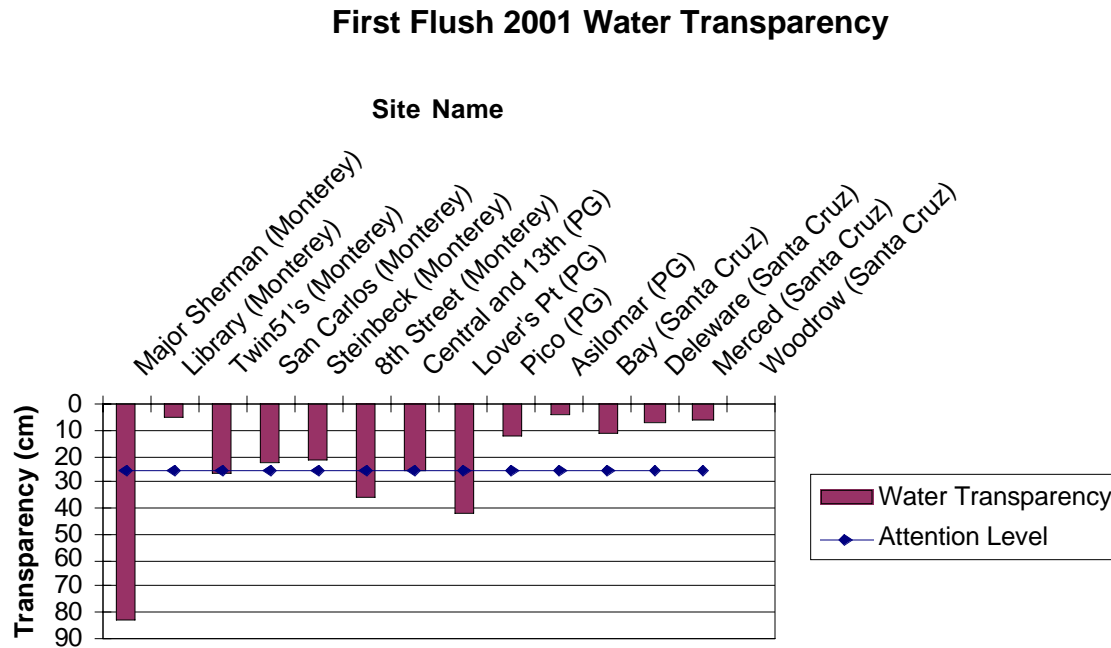
Transparency is another method of measurement to determine the amount of sediment suspended in the water column. Nine of the fourteen sites reported values less than the CCAMP Action Level for transparency of 25 cm. That means that the water was so turbid that a miniature secchi disc could not be viewed through 25 centimeters of water. The Library, Asilomar, and Merced sites had transparency less than 6 cm.

Figure 3. Transparency measured in cm by site. The sites are listed by city traveling from east to west. The values for time series locations reflect the minimum result.

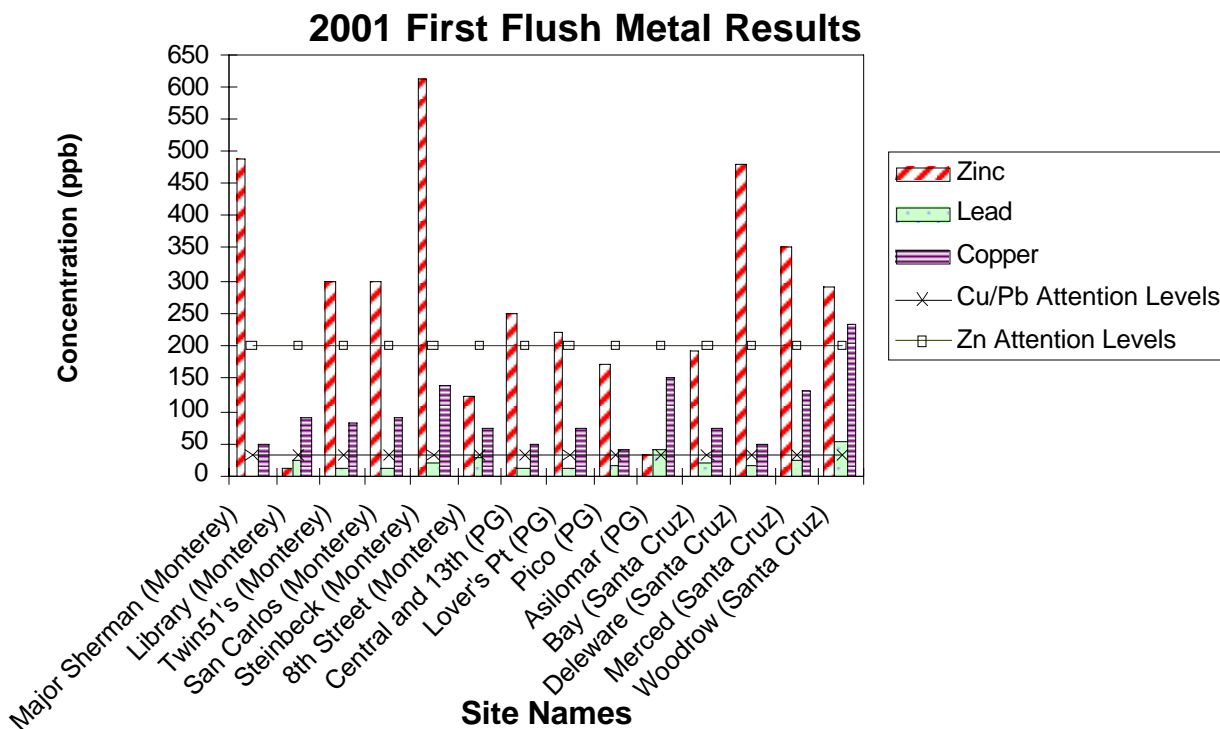
The background concentration for Cu in sea water is 2 parts per billion (ppb). Copper concentrations ranged from 40 – 230 ppb. The Basin Plan standard established for Cu is 30 μ g/l (ppb) so every site monitored exceeded this standard. The highest concentration was 230 ppb found at Woodrow in Santa Cruz. Woodrow was one of the sites chosen to be a “time series” station. The time series results were; sample #1 – 230 ppb, sample #2 – 170 ppb, sample #3 – 100 ppb and sample #4 – 100 ppb. Other locations with levels four times greater than the action level included Steinbeck Plaza, Asilomar and Merced(See Figure 4). Steinbeck Plaza and Asilomar recorded the highest concentration of copper in First Flush 2000 as well.

The background concentration for zinc (Zn) in sea water is 8 ppb. The Basin Plan standard for Zn is 200 ppb ($\mu\text{g/l}$). In 2000, this value was exceeded at just one station, Steinbeck Plaza in Monterey. In 2001, nine of the fourteen sites exceeded the action level. Zinc concentrations ranged from 10 – 610 ppb (See Figure 4). Steinbeck Plaza, once again had the highest concentrations, with a time series of 610 ppb, 440 ppb, and 490 ppb respectively.

Lead (Pb) concentrations ranged from non-detect to 52 ppb. The Basin Plan standard for lead is 30 ppb. For the second year, Asilomar was the only site in Monterey and Pacific Grove to exceed this value with a concentration of 41 ppb. The level at Asilomar in 2000 was 35 ppb (See Figure 4). Woodrow, in Santa Cruz, also exceeded this action level in the final two of four time series samples with concentrations of 32 ppb and 52 ppb.

Figure 4. Depicts metal concentrations ($\mu\text{g/l}$ or ppb). They are listed in order traveling from east to west. The lines represent the Basin Plan standard. The values for time series locations reflect the maximum result.
