# Snapshot Day

May 4<sup>TH</sup>, 2013

## Final Report

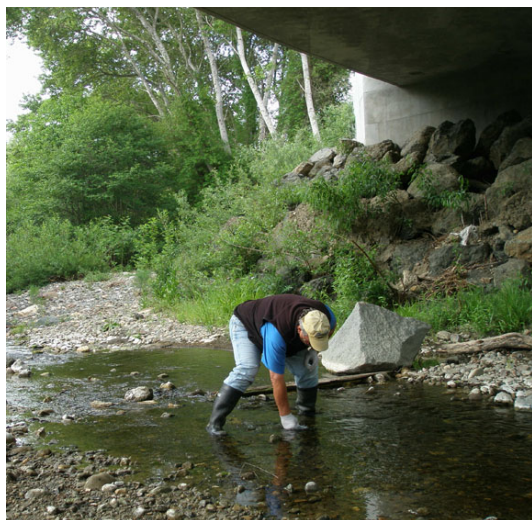
Taking a sample mid stream, facing up stream.

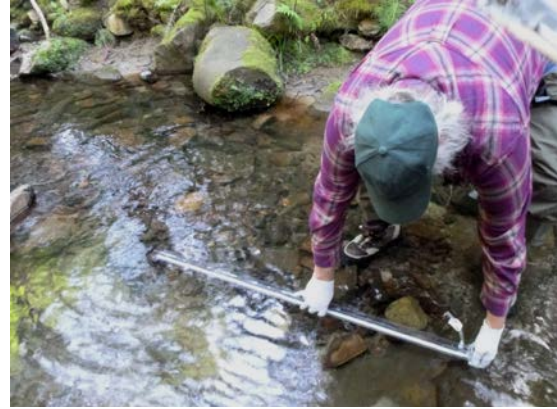
Volunteer collects water in transparency tube.

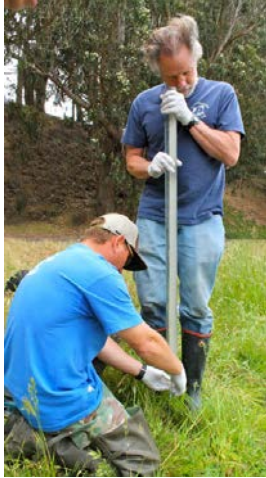
A team checks transparency.

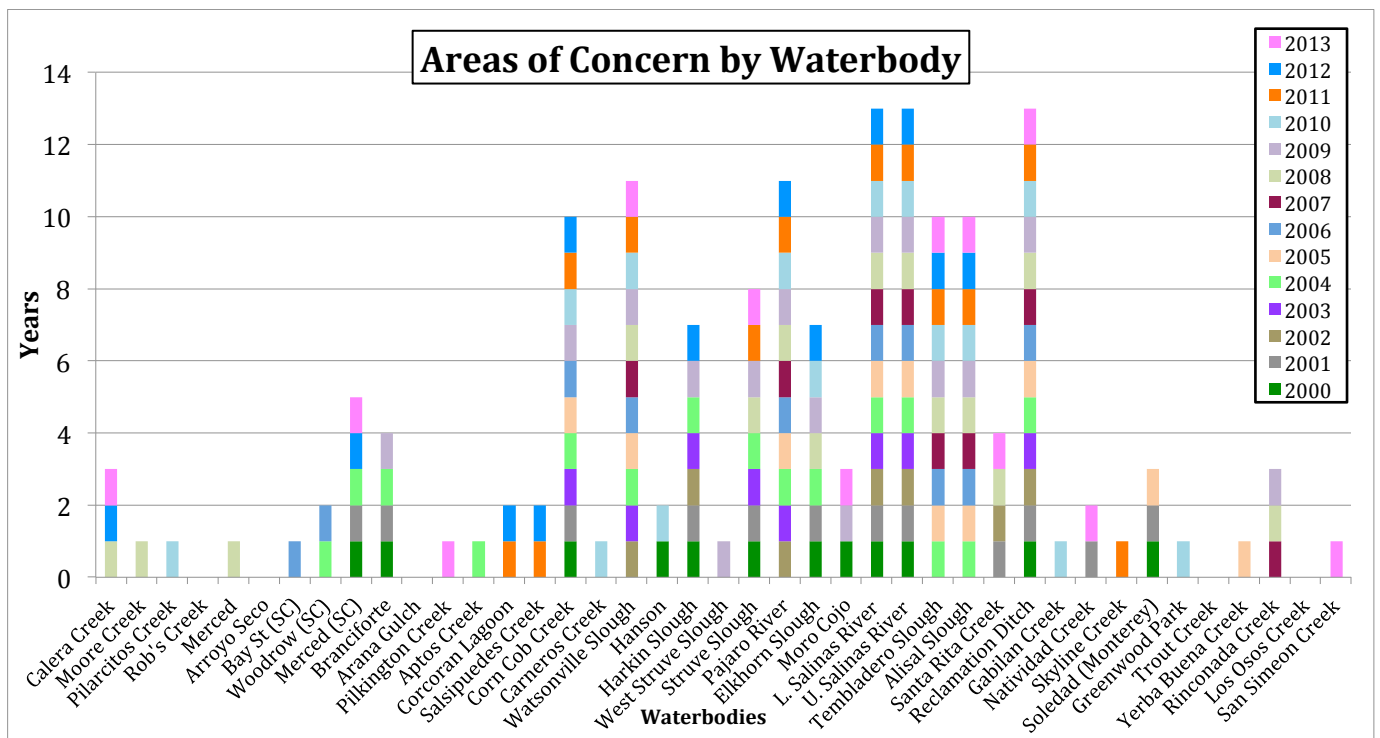
Figure 5. Areas of Concern by water body 2000-2013.

In 2013, sixteen sites (9%) were designated Areas of Concern on twelve water bodies (Figure 5). For the most part, AoC are designated and stay on the list for many years. However, Harkins Slough was not on the 2013 AoC list even though it had been for the past ten out of twelve years (Figure 6). New to the AoC list this year is, Pilkington Creek in Santa Cruz. It is a fairly urbanized area and is listed for exceedances in *E. coli*, orthophosphate (as P), dissolved oxygen and pH. Also back on the AoC list this year after a one year hiatus is Natividad Creek in Salinas due to exceedances in *E. coli*, nitrate (as N) and water temperature. All data is available in Appendix 1.
